South Humber Bank Energy Centre Development Consent Order

Appendix 10E: Otter and Water Vole Survey

Applicant: EP Waste Management Limited
Date: October 2019

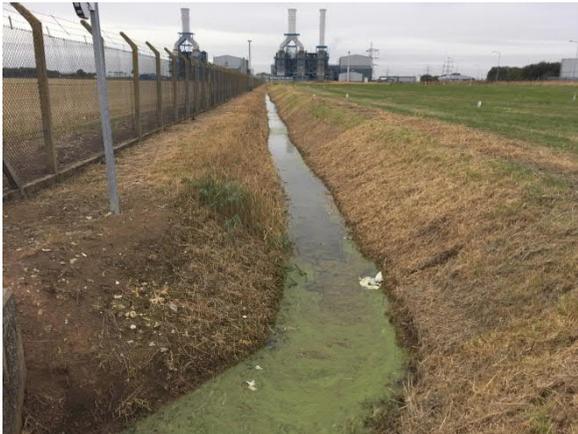
DITCH/ POND REFERENCE	DESCRIPTION	RELATIONSHIP TO THE SITE AND MAIN DEVELOPMENT AREA	WATER VOLE FIELD SIGNS	OTTER FIELD SIGNS	PHOTOGRAPH
1	A wet drain supporting a continuous linear stand of emergent and marginal common reed (<i>Phragmites australis</i>) dominated swamp vegetation	Outside Main Development Area. Runs along southern boundary of Site.	✓	✓

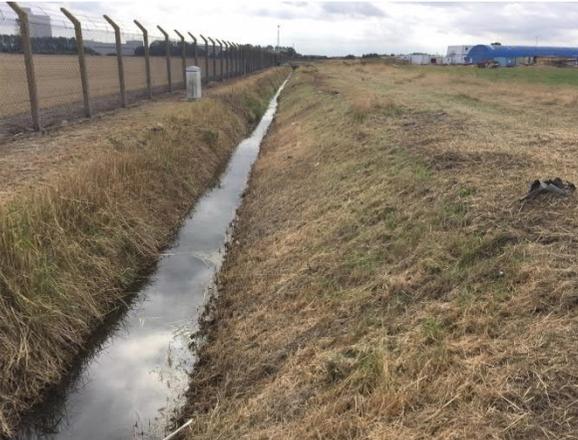
2	A wet drain supporting a continuous linear stand of emergent and marginal common reed dominated swamp vegetation	Outside Main Development Area. Runs along southern boundary of Site.	✓	x

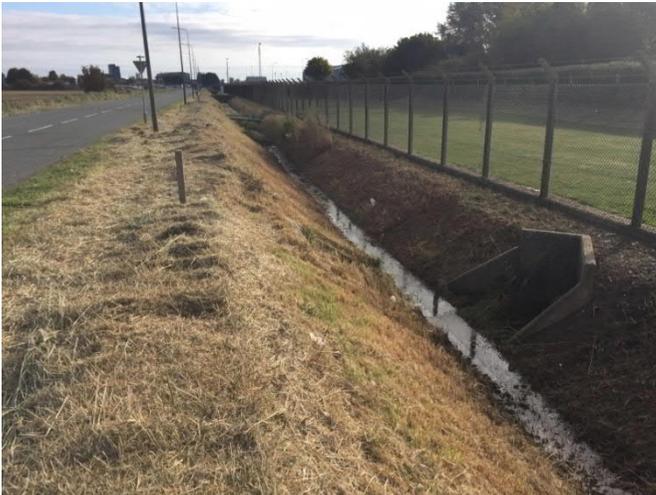
DITCH/ POND REFERENCE	DESCRIPTION	RELATIONSHIP TO THE SITE AND MAIN DEVELOPMENT AREA	WATER VOLE FIELD SIGNS	OTTER FIELD SIGNS	PHOTOGRAPH
3	<p>A wet drain with locally abundant emergent bulrush (<i>Typha latifolia</i>). Semi-improved neutral grassland riparian habitat with frequent herb species e.g. great willowherb (<i>Epilobium hirsutum</i>) and water mint (<i>Mentha aquatica</i>).</p> <p>The vegetation had been cut at the time of the survey.</p>	<p>Within Main Development Area. Runs along northern boundary of Site to South Marsh Road.</p>	✓	x

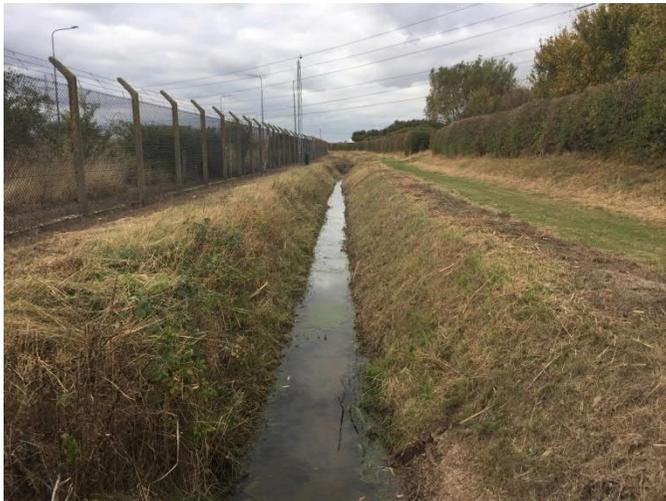
DITCH/ POND REFERENCE	DESCRIPTION	RELATIONSHIP TO THE SITE AND MAIN DEVELOPMENT AREA	WATER VOLE FIELD SIGNS	OTTER FIELD SIGNS	PHOTOGRAPH
4	<p>A wet drain with occasional emergent and marginal common reed semi-improved neutral grassland riparian habitat with occasional herb species. The vegetation had been cut at the time of the survey.</p>	<p>Outside Main Development Area. Runs along eastern boundary of Site.</p>	✓	✓

- 3.8 An old otter spraint was also recorded on Ditch 4 during the survey in October 2018. No other signs of otter were found at this time.

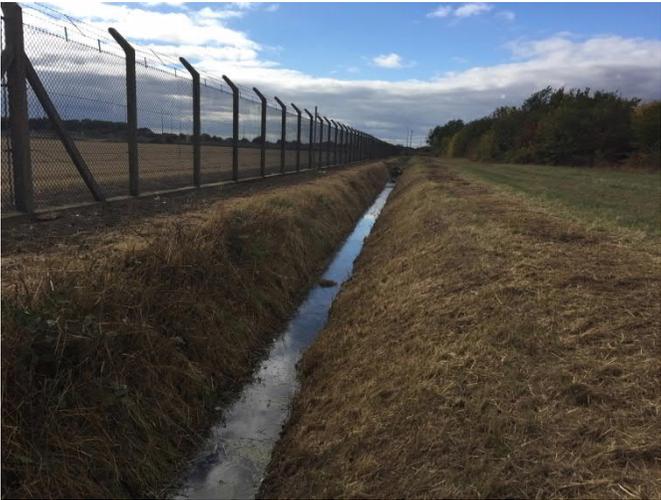
DITCH/ POND REFERENCE	DESCRIPTION	RELATIONSHIP TO THE SITE AND MAIN DEVELOPMENT AREA	WATER VOLE FIELD SIGNS	OTTER FIELD SIGNS	PHOTOGRAPH
5	A wet drain supporting a continuous linear stand of emergent and marginal common reed dominated swamp vegetation. The vegetation had been cut at the time of the survey.	Outside Main Development Area. Runs along southern boundary of Site.	✓	x

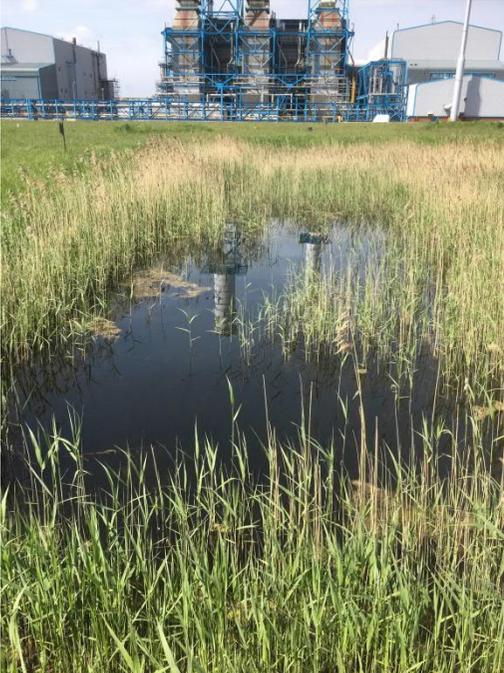
DITCH/ POND REFERENCE	DESCRIPTION	RELATIONSHIP TO THE SITE AND MAIN DEVELOPMENT AREA	WATER VOLE FIELD SIGNS	OTTER FIELD SIGNS	PHOTOGRAPH
	water star-wort (<i>Callitriche</i> spp.)				
Pond 1	Small pond with dense marginal fringe of common reed. No longer present in 2019.	Within Main Development Area.	x	x

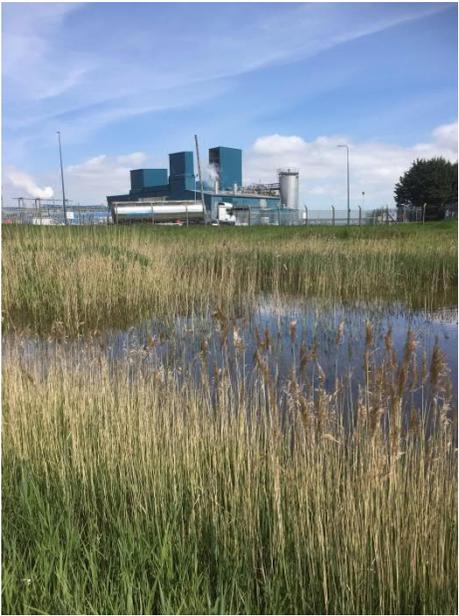
DITCH/ POND REFERENCE	DESCRIPTION	RELATIONSHIP TO THE SITE AND MAIN DEVELOPMENT AREA	WATER VOLE FIELD SIGNS	OTTER FIELD SIGNS	PHOTOGRAPH
Pond 2	Small pond with dense marginal fringe of common reed. No longer present in 2019.	Within Main Development Area.	✓	x

- 4.2 There was also field evidence to suggest that water voles were likely to be using Pond 2 for foraging, although it was not considered that water voles would be resident on the pond given its small size. No burrows or droppings were found to indicate permanent presence during the survey (or the subsequent ecological watching brief during pond infilling). It is more likely that occasional foraging activity occurred by the population present on the surrounding ditches. Pond 1 was also in close proximity to a ditch in which water vole field signs were found, and therefore may also have been used on occasion by foraging water vole. The ponds were infilled in 2019 under ecological supervision and no water voles were found during these works.
